EMERISDA

Effectiveness of methods against rising damp in buildings:

European practice and perspective

FINAL REPORT

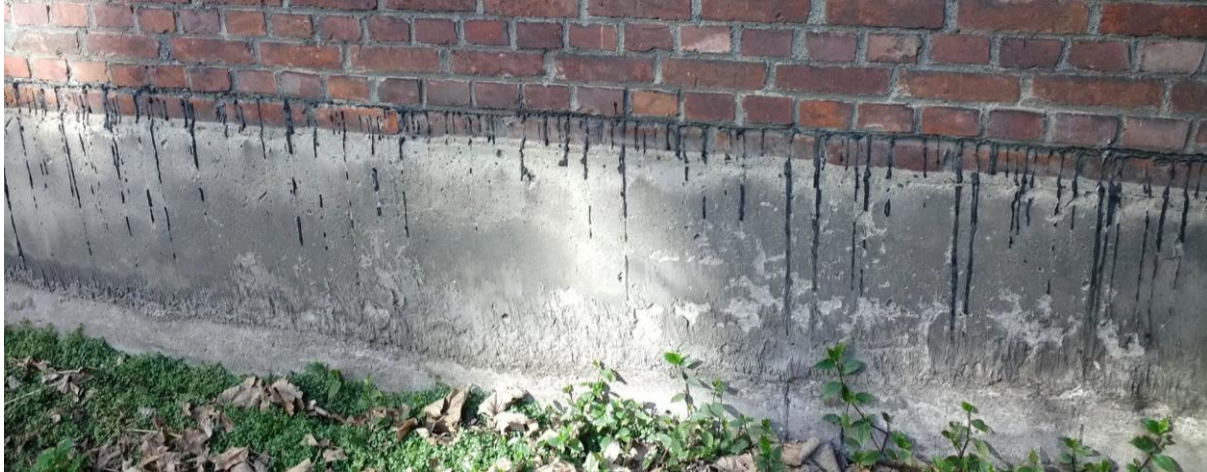
Figure 3: an example of an old (successful) attempt to avoid rising damp in a wall. The layer of tar is still efficient nowadays. Clearly the layer of tar was not applied in a very careful way, but this does not affect its efficiency.

- Application of a thin, watertight, material, in between to layers of bricks near the base of the wall. In old literature we see lead, zinc, even glass. Another option was to apply a layer of tar when the masonry reached a certain height, after which the masonry was continued (see figure 3).

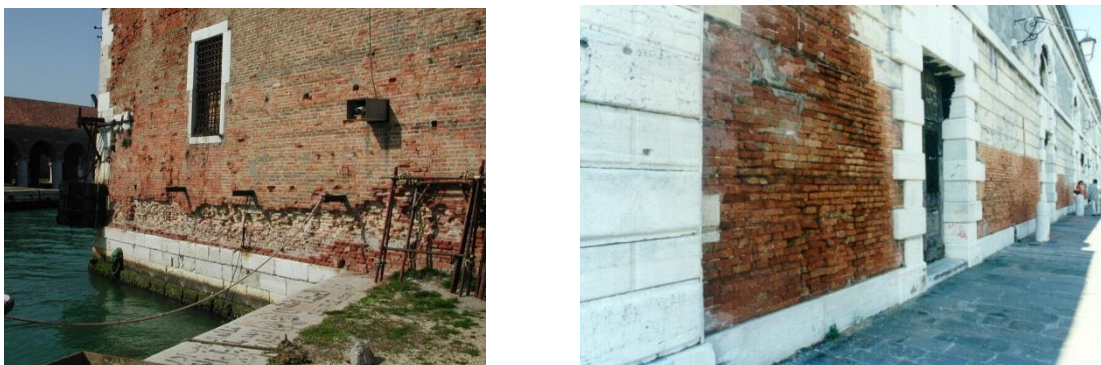
Figure 5: Alberaria Tower (Venice) and Salt emporium (Venice): horizontal courses of Istria stone blocks were used at the base of the walls to limit the capillary rise of water.

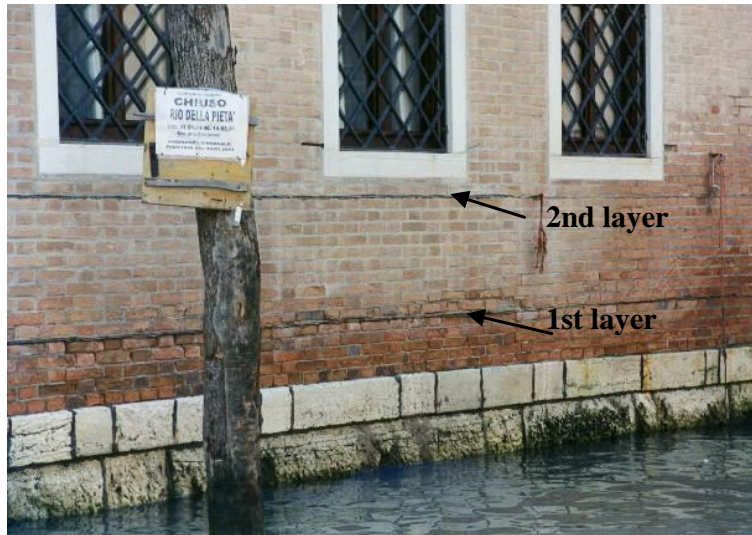
Figure 7: Presence of mechanical interruption (2 layers) in a building in Venice

A wide range of materials can be used for the sheets, such as steel or lead plates, plastic, glass, bitumenbased membranes, polyethylene or polyester-based, PVC membranes (e.g. gallerie dell'Accademia (Convento della Carita) (Franzoni (2014)). In Venice the use of lead plates and bitumen paper are common. Because of the water often exceeding the level of the original mechanical cut, in some cases a second layer, at a higher level in the wall, is added (figure 7).

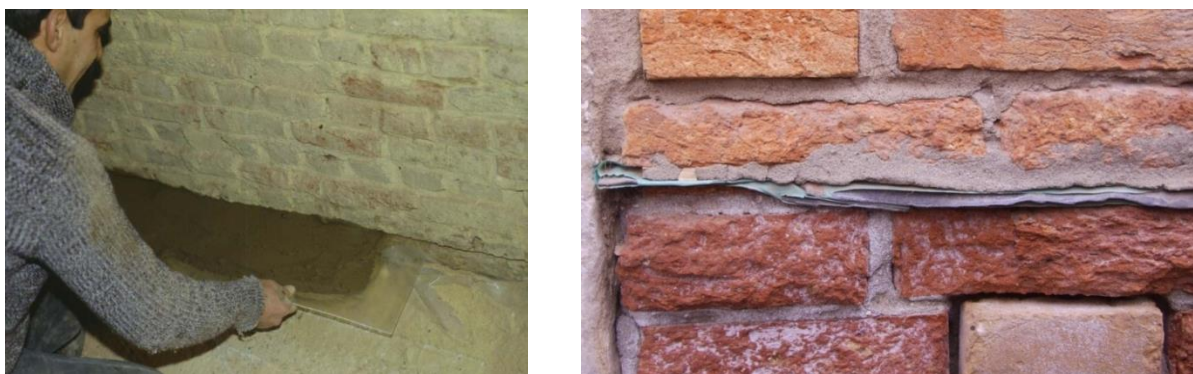
Figure 8: applications and result of a mechanical interruption

- The mechanical interruption leaves a visible layer in the masonry (figure 8), fact which may alter the aesthetic value of a cultural heritage building.

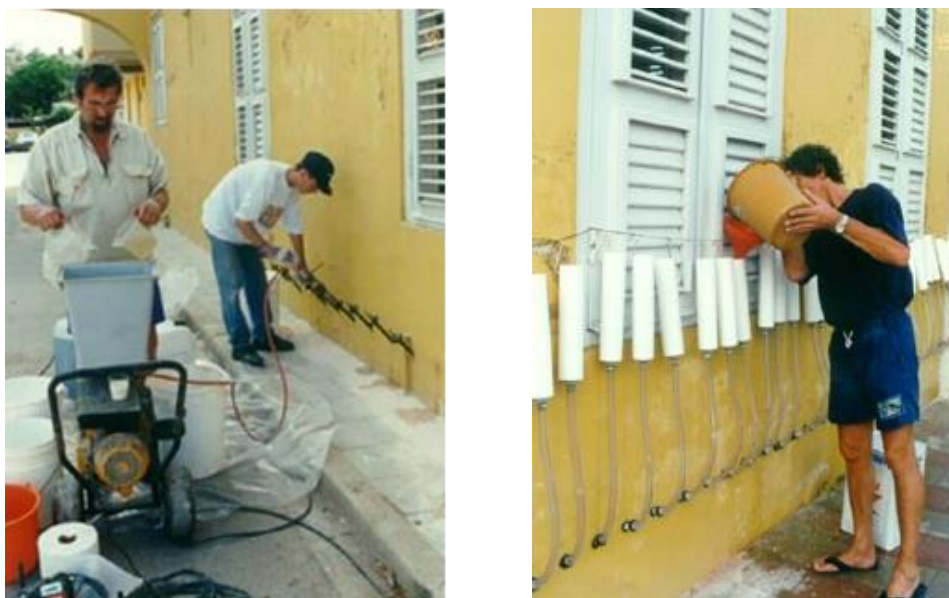
Figure 9: Treatment of a wall using pressure (injection) (on the left) and using only hydrostatic forces (impregnation) (on the right)

Chemical interruption is also known as chemical damp-proofing, chemical barriers, chemical injections or damp-proof courses. The chemical interruption is created by drilling holes at the base of the wall along a horizontal profile. The distance and depth of these holes are depending on the type of product and on the material of the masonry. Normally intervals at a distance of 10-15 cm from each other are used, up to a depth of approximately $\frac{3}{4}$ of the wall thickness (De Bruyn et al. (2003), Herinckx and Vanhellemont (2014), van Hees et al. (2008)). Generally holes for treatment with liquid products are drilled in an angle (30 - 45 °), while for more viscous products horizontal holes are used. The aim is to create a horizontal barrier through and through the horizontal section of the wall. Depending on the thickness and on the accessibility of the wall, the holes can be drilled from one side or from two sides of the masonry. The holes are filled with the chemical product either with pressure (injection), or without pressure (impregnation).

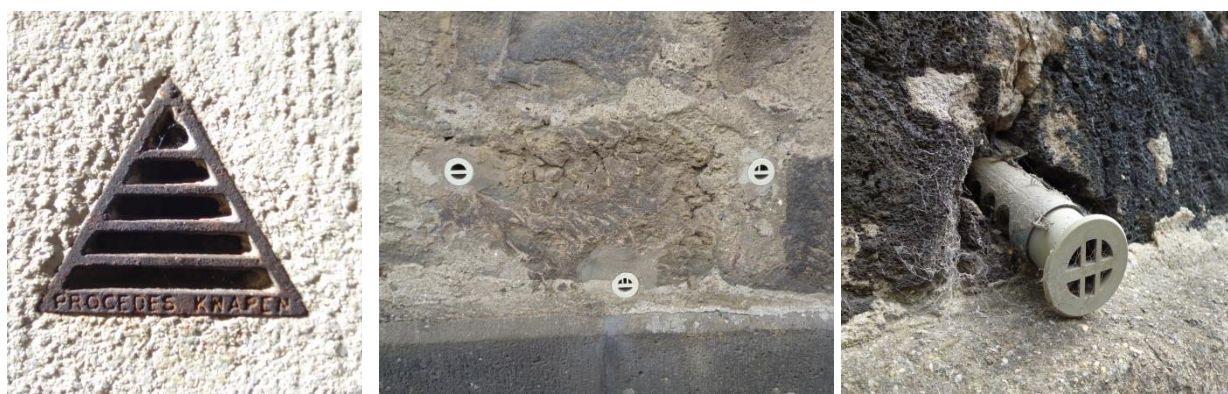
Figure 10: Different types of Knapen Siphons in a wall (Lubelli, B.)

Since the early 20th century the so-called ‘Knapen siphons’ or ‘Knapen tubes’ or ‘Atmospheric siphons’ i.e. fired clay or perforated plastic or metal tubes were inserted in the masonry. Originally they were made of ceramic tubes placed in a hole drilled in the wall. The principle of these methods is to enhance the drying process by accelerating the evaporation (Camuffo (2013)). The principle behind this atmospheric drainage siphons is that damp air is heavier than dry air (Torres (2007)). Knapen believed that inserting oblique drainage tubes into walls, would release damp air coming from inside the wall, thereby facilitating the wall-drying (process). However, the Knapen-siphons were proven to be barely successful in moisture removal in laboratory testing, where the bare holes proved to be more effective [Heiman]. As a matter of fact, some conditions were found to unfavourably influence the effectiveness of Knapen tubes, such as unheated rooms, absence of direct solar radiation, and dense building materials, to an extent that the tubes might sometimes even cause the wall to become damper. This reverse action might also be possible in case of high outdoor air relative humidity (supply of moisture to the wall) (Franzoni (2014)). It should be noted that these tubes may form a thermal bridge, and thus responsible for heat losses in the building (De Bruyn et al. (2003), Herinckx and Vanhellemont (2014)).

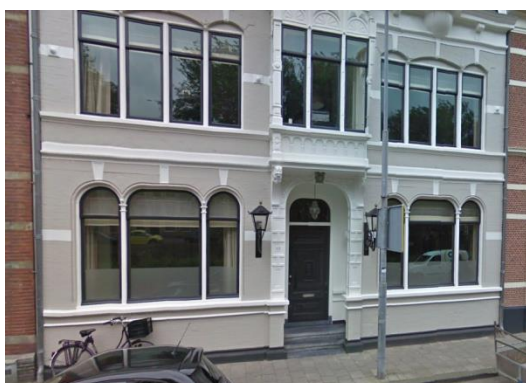
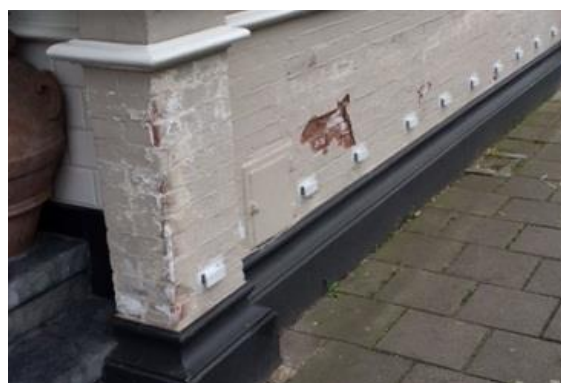
Figure 14: Before and after application Schrijver Systeem, Raamsingel 42, Haarlem (Google Maps september 2009 - Miedema, L. 2014)

Regarding the compatibility of these systems, both the Knapen siphons and drying stones have impact on the historical value of the building, because parts of the wall are taken out. This is much more relevant in the case of the Schrijver system. Considering the aesthetic aspect, both systems are clearly visible in the façade, as can be seen in figure 14.

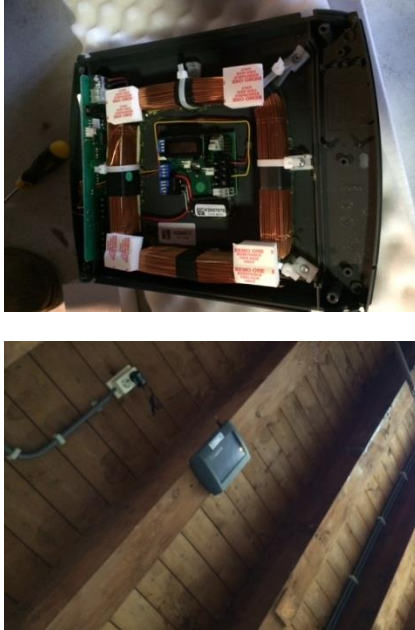
Product/system	Principle according to producer	Picture
<p>Ecody (The Netherlands, Italy, Germany, Czech Republic, Austria, Greece, Denmark, Slovenia, France, Spain)</p>	<p>“Ecody works with integrated Impulse-Resonance Techonology which disturbs the process of rising damp. The effect is that the water returns to the soil. Ecody also causes an increase in the evaporation at the surface. There are different systems which have a reach of 12,5-14m (www.ecody.de)</p>

<p>Ecody system at Paardenmarkt, Delft (Miedema, L.)</p>
<p>De muurontvochtiger (The Netherlands, Germany)</p>	<p>“The system is an active process on an electrophysical base. Its principle is based on the existing potential of an opposite electrical field. This potential is reduced to ground level. The moisture and the soluble salts in it follow the polarity and migrate within a few weeks back to the soil. The difference in potential is reversed. By a right application of the product, after 4-6 weeks measurable results be determined. An improvement of the indoor climate can be seen. After 3-5 months one can usually start the renovation.” [www.demuurontvochtiger.nl]</p>

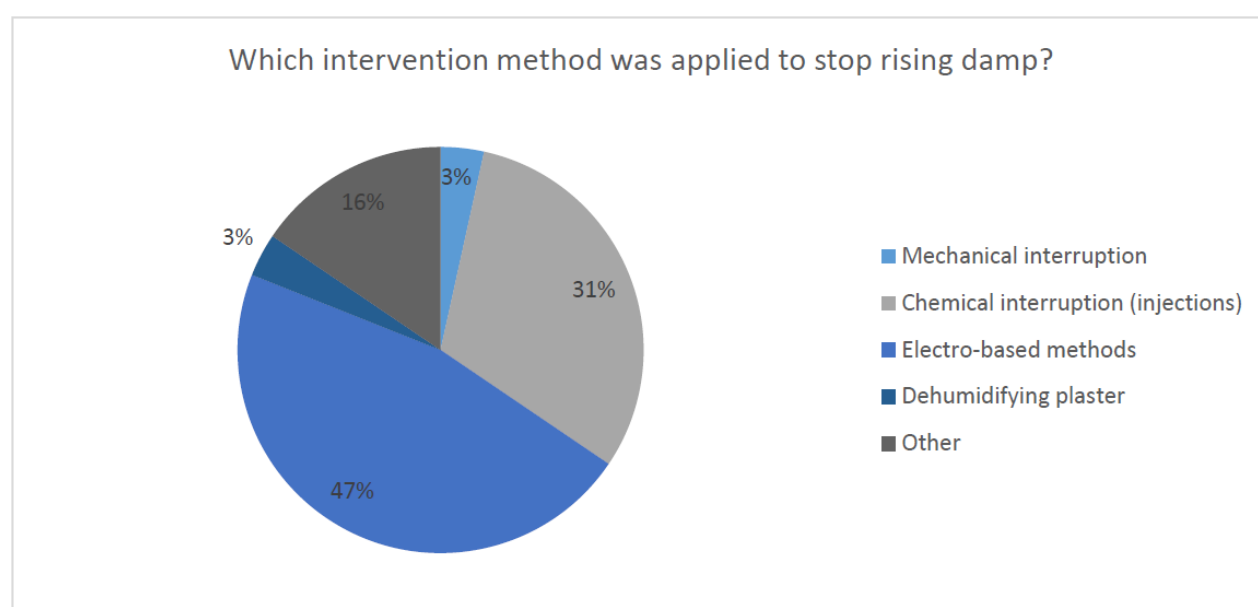
Figure 20: methods used to treat rising damp

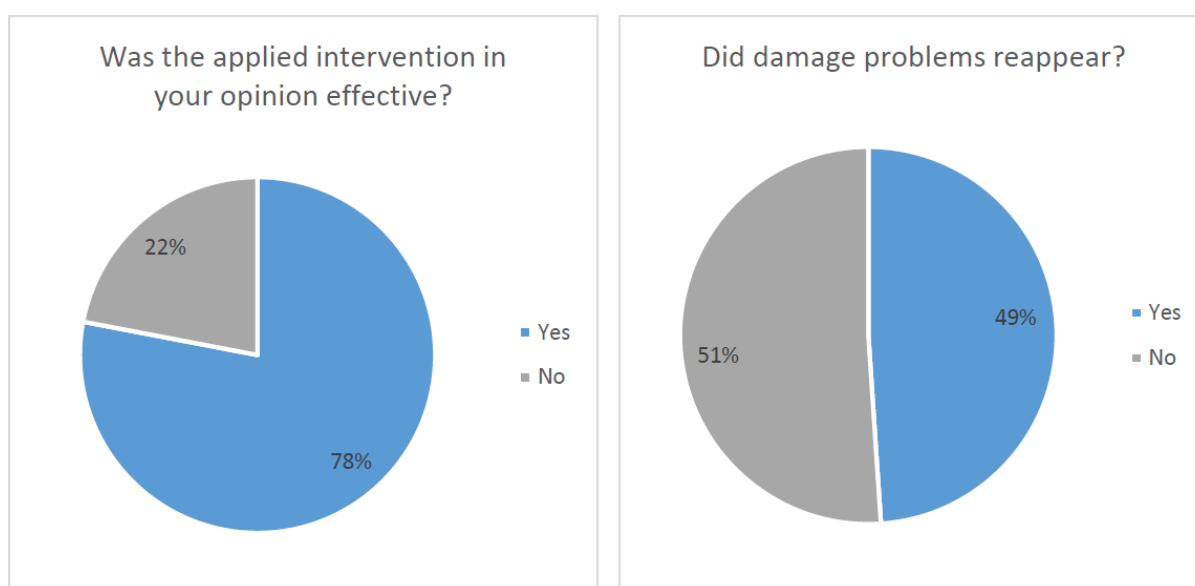
Figure 24: statistics regarding user's satisfaction

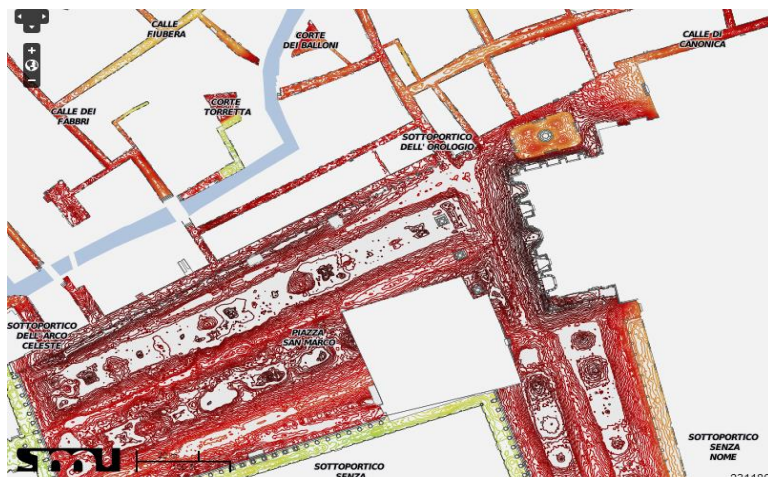
Figure 28: Altimetry of the Saint Mark's Square area according to the Ramses system (Municipality of Venice)

Ground level on Comune Marino according to Ramses system (Insula): around +80 cm on comune marino (C.M.), Crypt: -18 cm on comune marino.

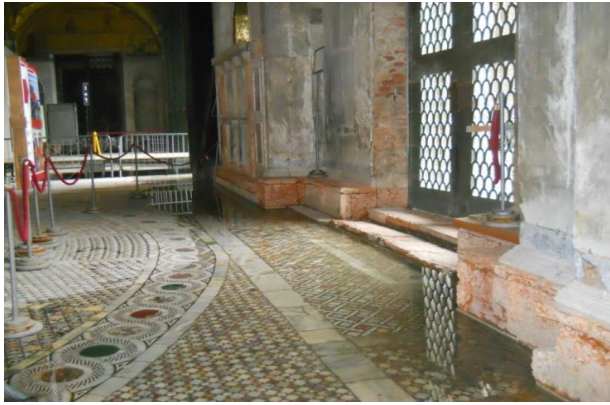
Figure 29 Picture of the Narthex during a high tide event (water level +85 cm)

The narthex of the Basilica is frequently flooded by water due to its low height (+64-80 cm on the average sea level at Punta della Salute ZMPS) becoming a pool of salty water.

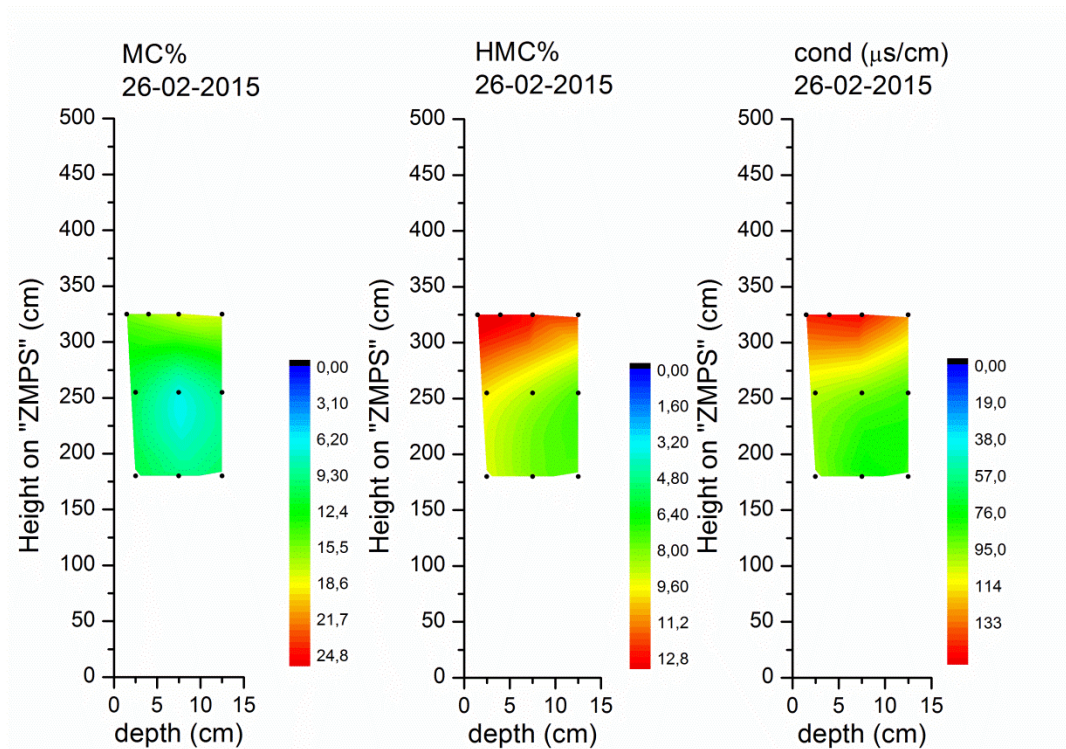
Figure 35: Moisture content, hygroscopic moisture content HMC and conductivity distribution in relation to the wall's height on sea level ZMPS and wall's depth.

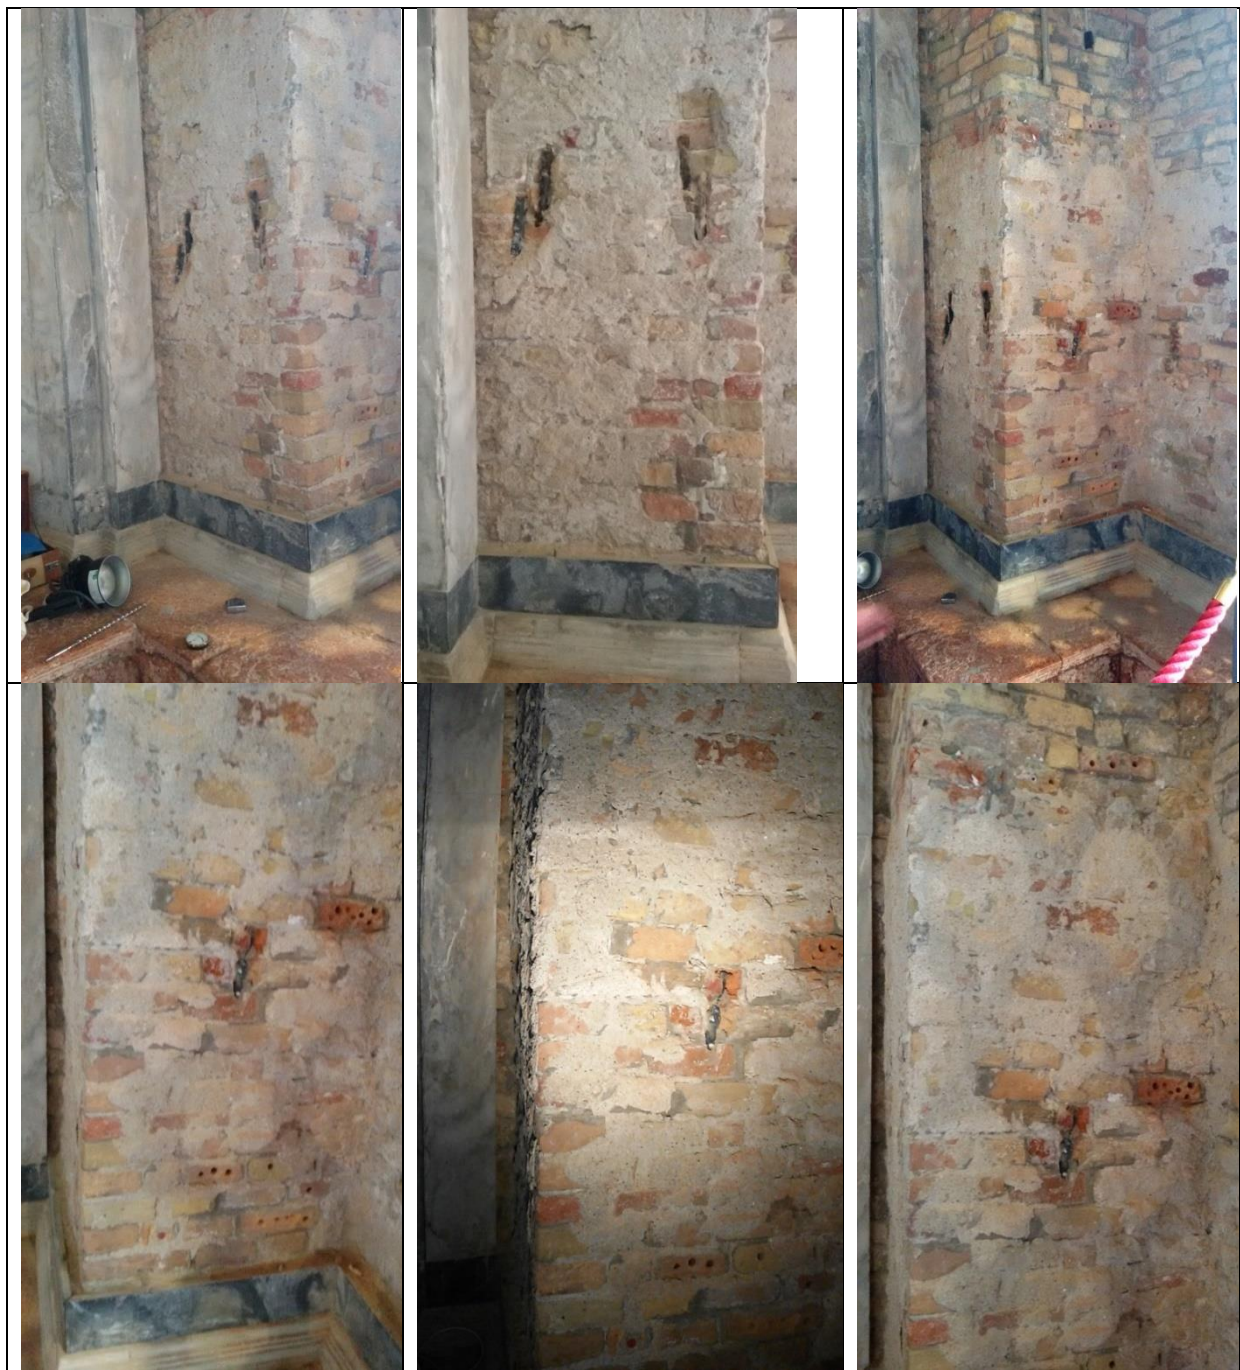
Figure 36: Pictures of the pillar before the second sampling campaign.

The visual inspection carried out during the second sampling (16/03/2016) evidence a situation similar to the previous one, but salt efflorescences were more diffuse also over the Rosso di Verona panels and over the bricks (figure 36).

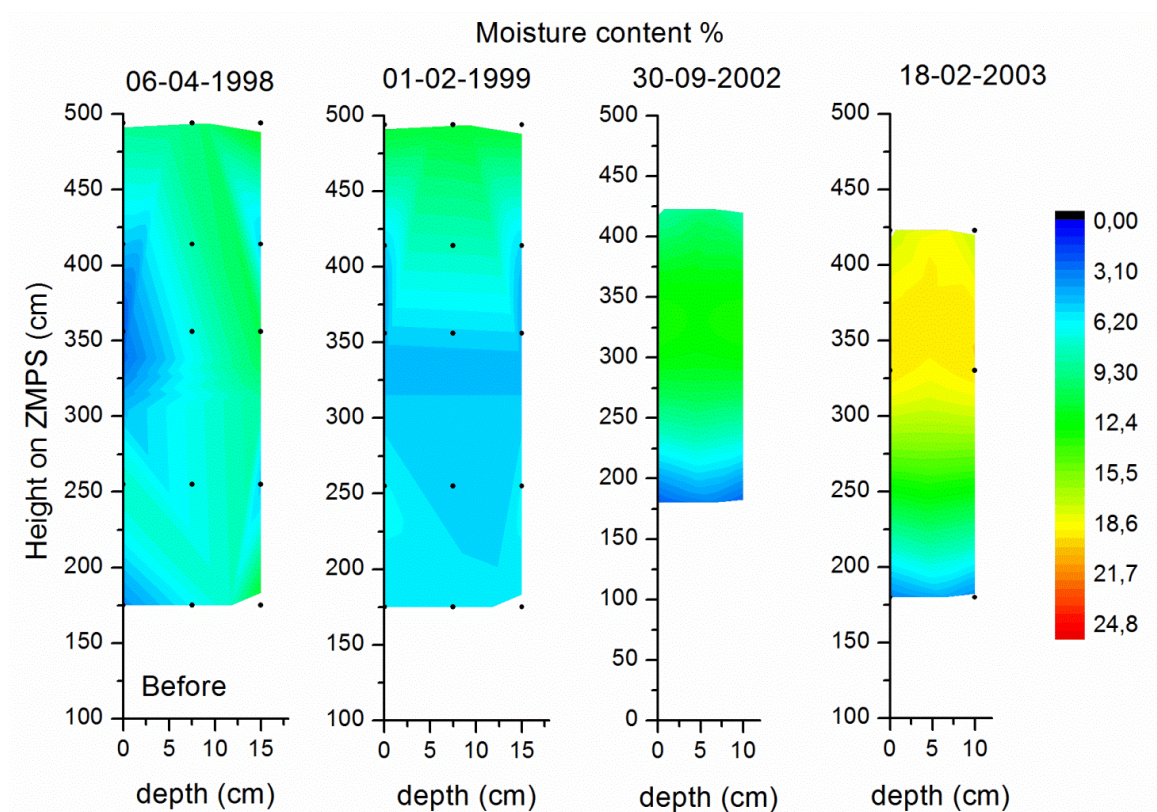
Figure 40: Moisture content distribution during the repeated sampling campaigns from 1998 to 2003

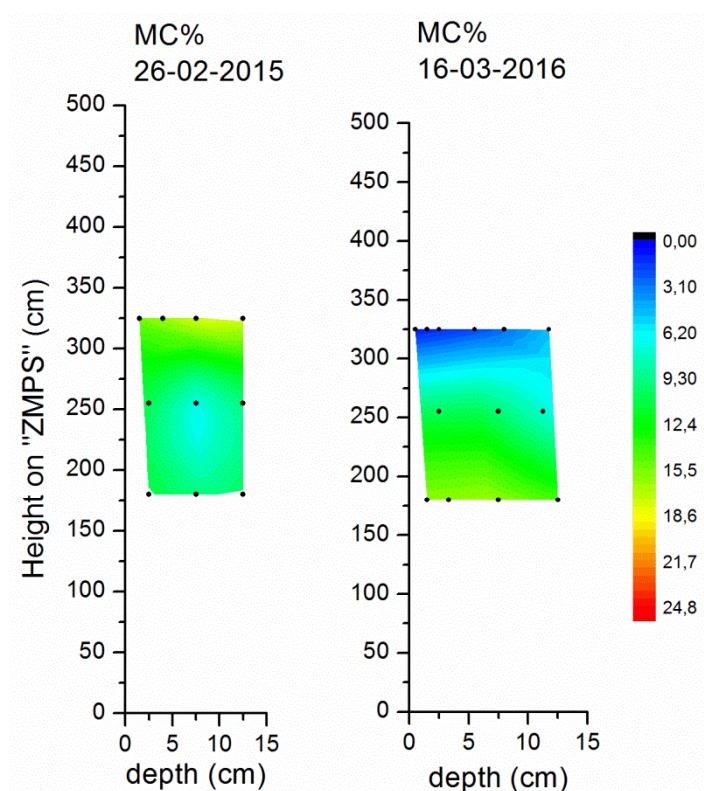
Figure 41: Moisture content distribution measured during the EMERISDA project

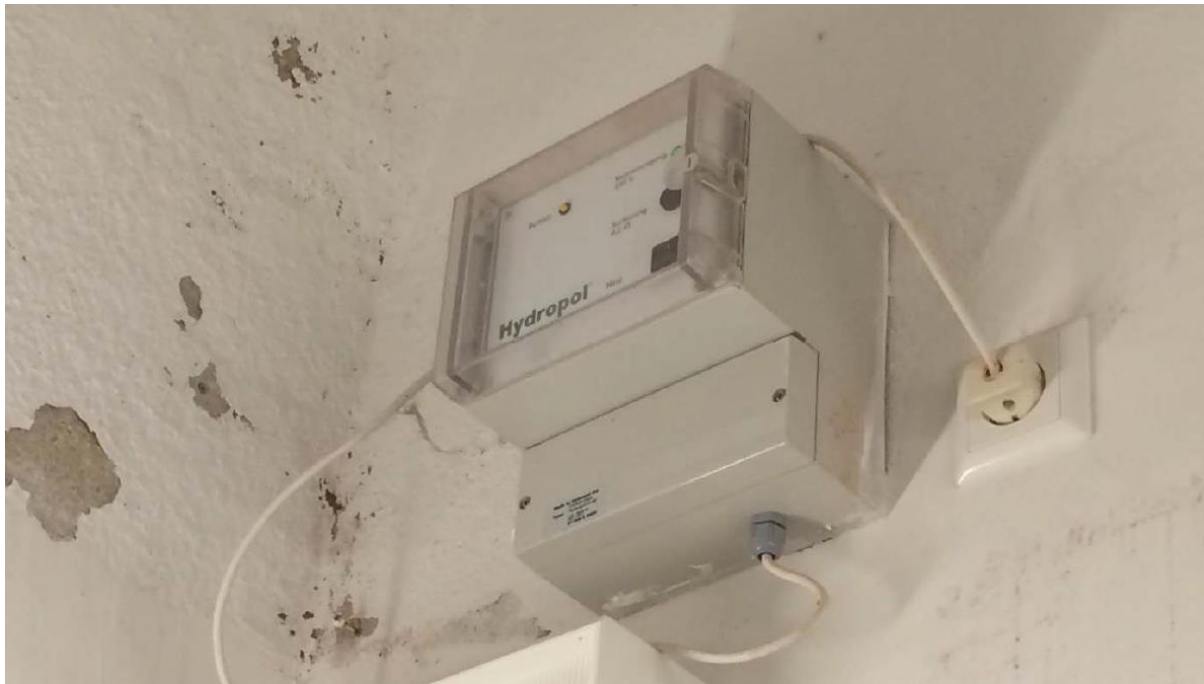
Figure 42: Installed Hydropol system in the coffeecorner. Picture by L. Miedema, 11-9-2014.

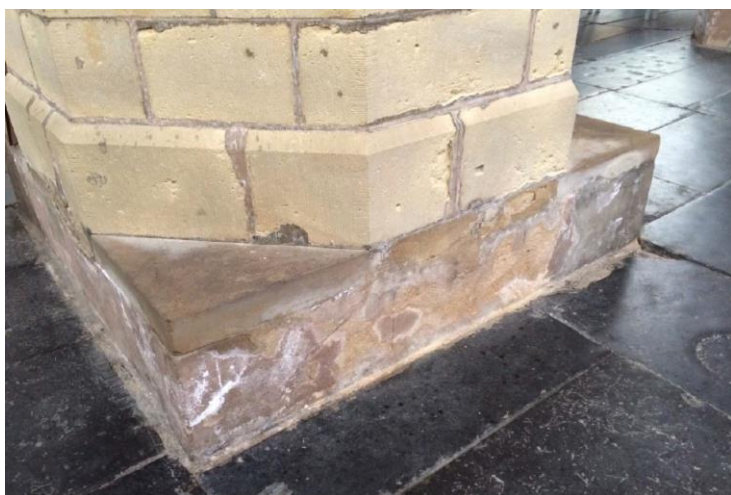
Figure 44: Efflorescence and stone damage at base of column (L. Miedema, 11-09-2014)

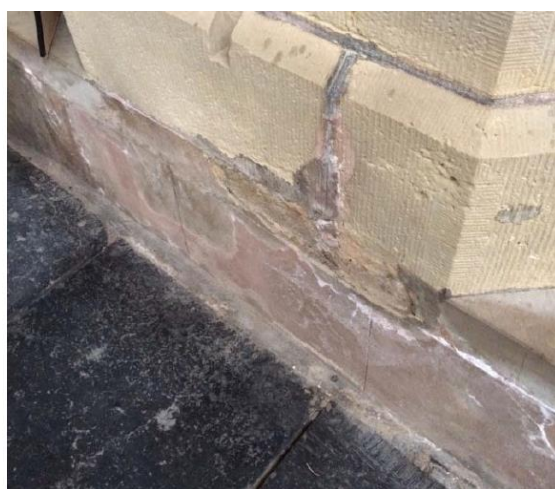
Figure 45: Efflorescence and stone damage at the base of columns. Right: detail of fig. 3.1. Note the pink colour on the base of the column (L. Miedema, 11-09-2014)

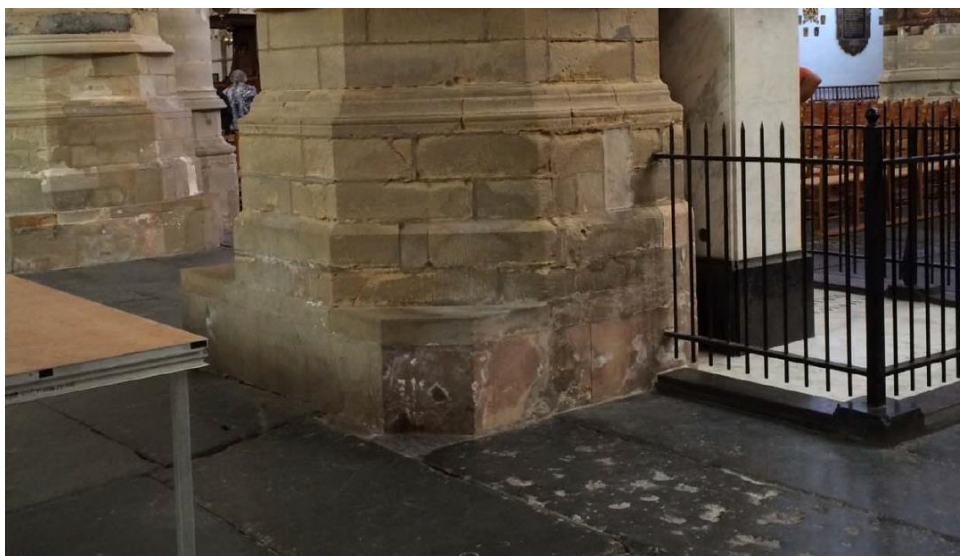
Figure 46: Efflorescence and stone damage at base of column. Damage to floor (L. Miedema, 11-09-2014)

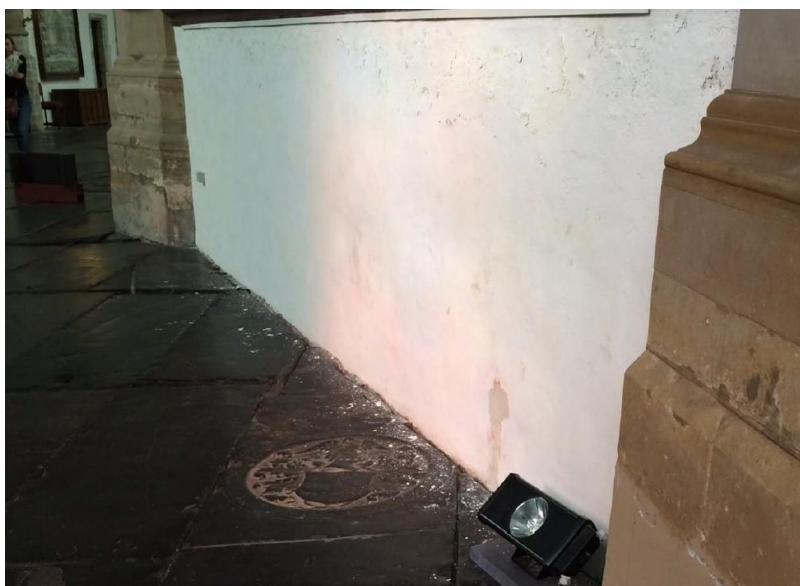
Figure 47: Damage to plaster as a result of efflorescence (L. Miedema, 11-09-2014)

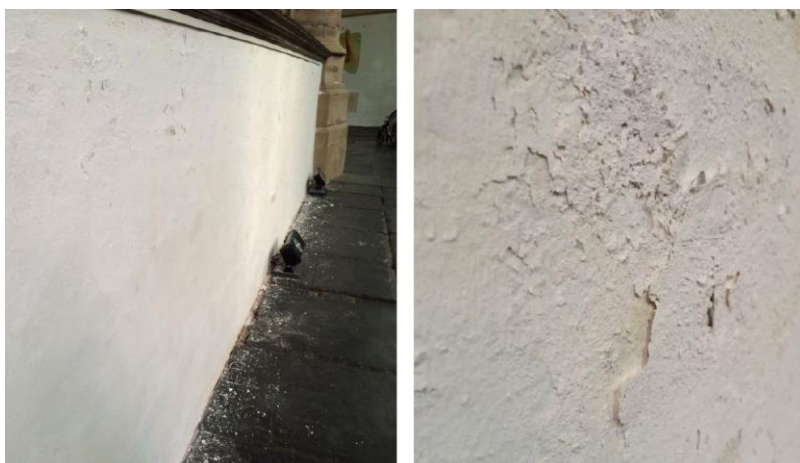
Figure 48: Damage to plaster as a result of efflorescence. Right: Detail showing damage to plaster and paint (L. Miedema, 11-09-2014)

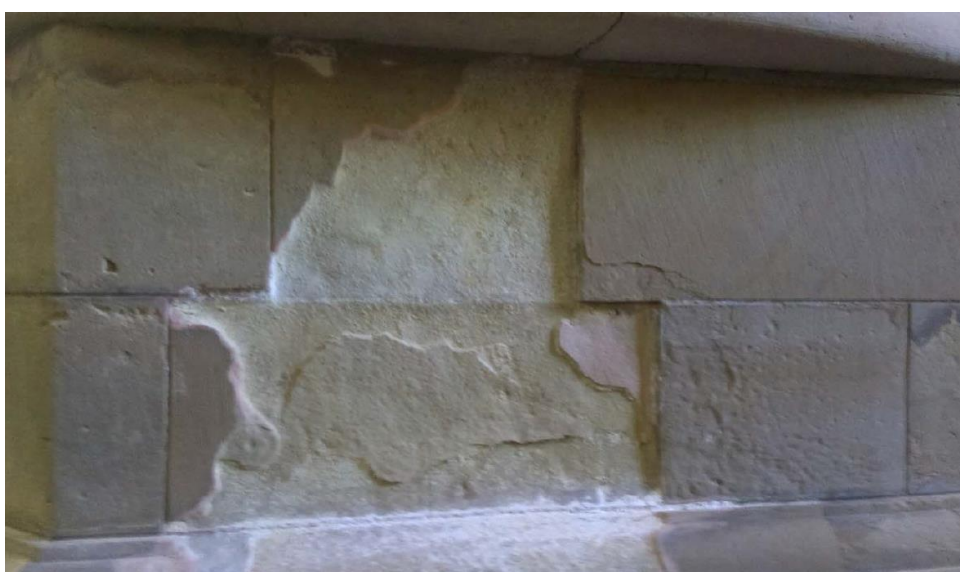
Figure 49: Scaling of stone (B. Lubelli, 09-10-2014)

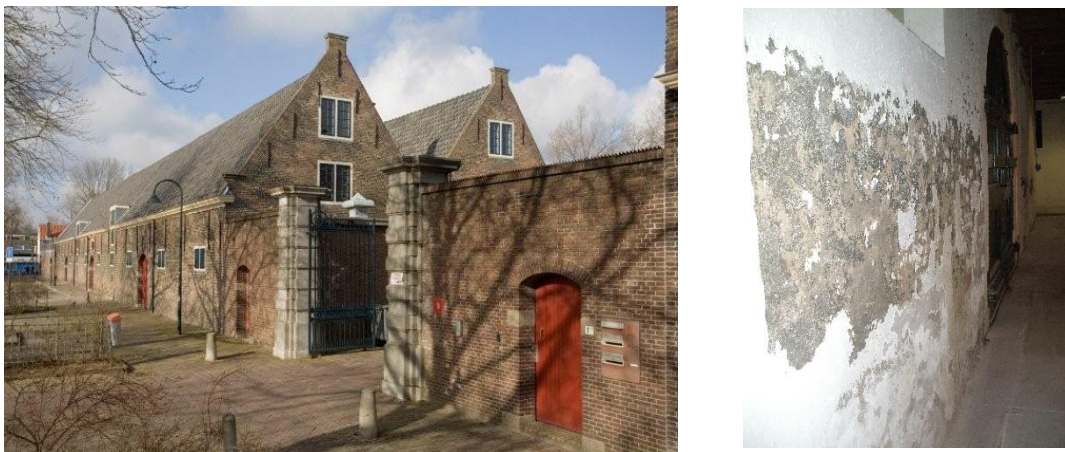
Figure 56: Artillery Warehouse, Paardenmarkt (Delft, Netherlands), exterior and damage in the interior

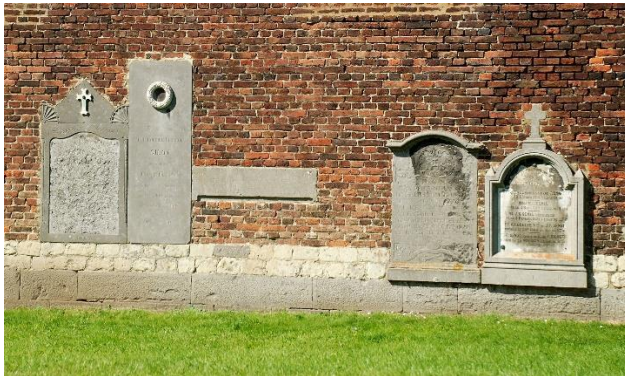
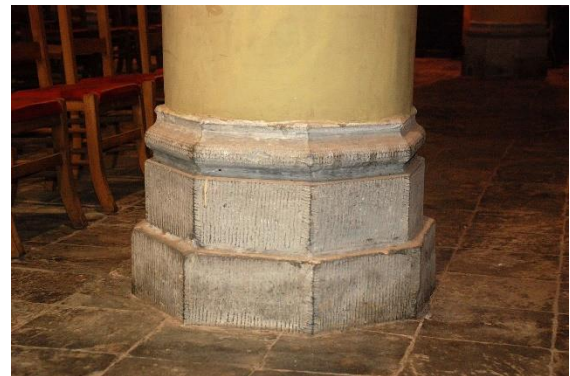
Figure 66: historic attempts to protect the building against rising damp. On the left: wall base constructed out of dense blue stone, and local sand-limestone. Notice the very thin vertical joints between the blue stones. On the right: the bases of the columns in one piece of dense blue limestone, which turns out to be a very efficient protection for the upper parts of the columns.

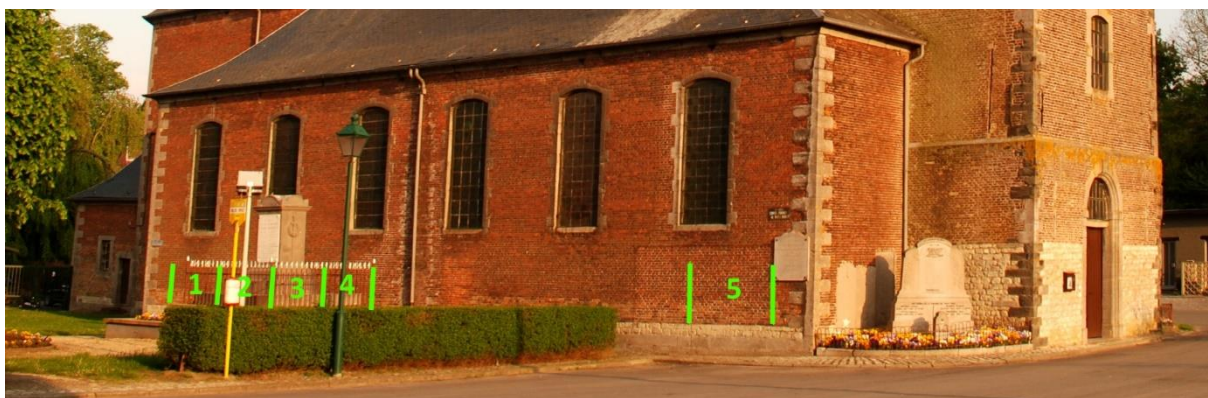
Figure 68: indication of the 5 test zones.

- Powder samples were collected by drilling. Drilling was carried out at different heights (0.2, 0.5, 1, 1.5 meters) and depths (0-7 cm, 7-15 cm, 15-30 cm, 30-50 cm, 50-80 cm) along a vertical profile. The samples were taken in a mortar joint, but deeper in the wall, the samples were always mixed mortar+brick, as could be expected from an irregular old masonry.
- The powder samples were collected in small plastic containers, which were then hermetically closed and transported to the laboratory for the measurements of the MC and HMC, according to the earlier explained methodology.

This was done for every of the 5 test zones.

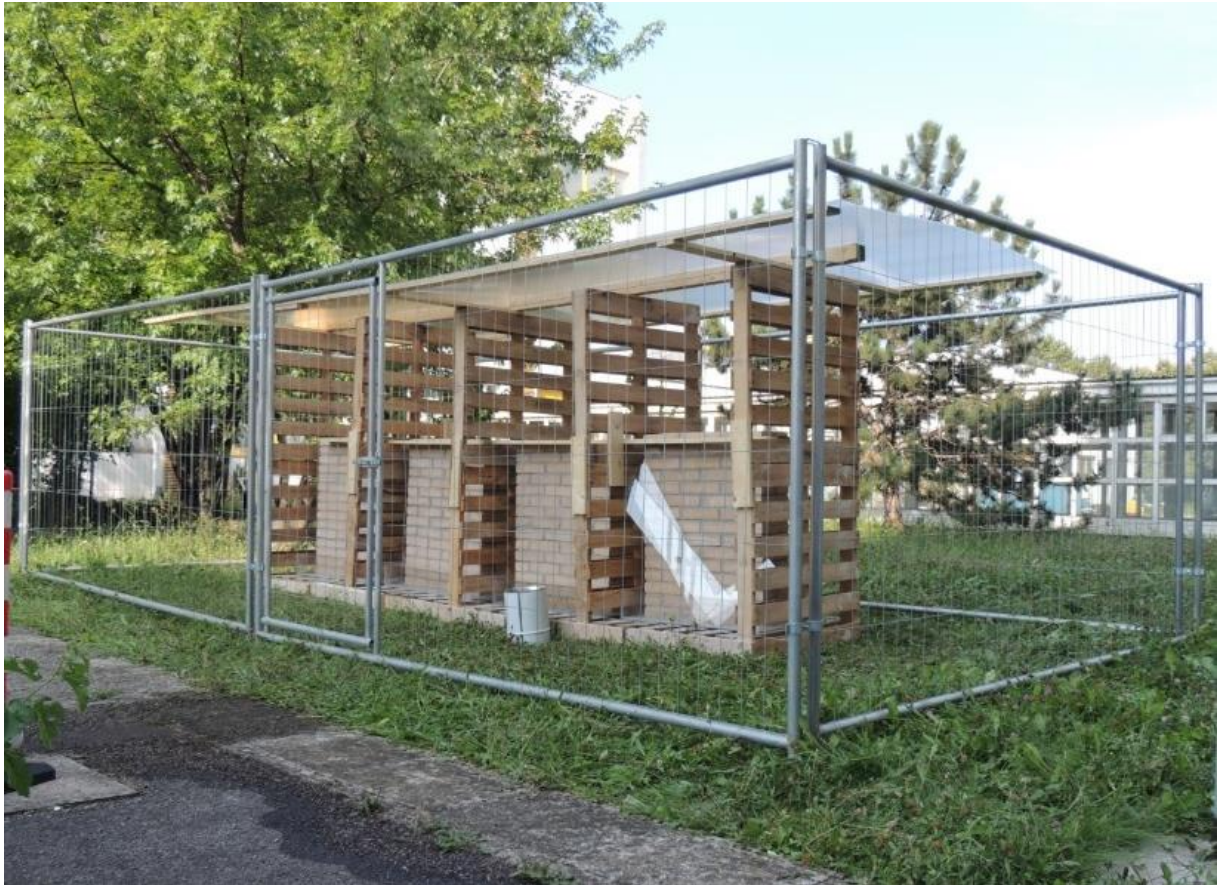
Figure 71: an overview of the 4 scale models on the campus of the Bologna University.

The scale models were designed and built by Restauri Speciali, the SME involved in the project. They were located in a delimited zone of the CNR campus “Bologna Research Area”, in the green area between the buildings of Institutes ISAC and IMM in July 2014. They were set in an area fenced-in with wire mesh temporary used in yard, in such a way to avoid the animal intrusion. The area had a dimension of 7 m × 3.5 m × 2 m (L × D × H) and one door access to allow the entrance to authorized personnel. The scale models were protected with a transparent sloping plexiglas roof in order to avoid the direct impact of rainfall and the snow accumulation during the winter period. The scale masonries were hosted in euro pallets to allow the stability of the structure and the anchoring of the shelter.

Bricks and mortars were combined to form four single walls each one of the dimension of 77 cm × 25 cm × 100 cm (L × D × H). San Marco “facing bricks” with the dimension of 12 cm × 5.5 cm × 5 cm (L × D × H) and a lime-cement mortar (*malta bastarda*) were used. Each wall consisted of fourteen courses laid in stretching bond, with one course comprising six bricks in a double width. The walls were erected in plastic trays and left for 30 days for the mortar curing.

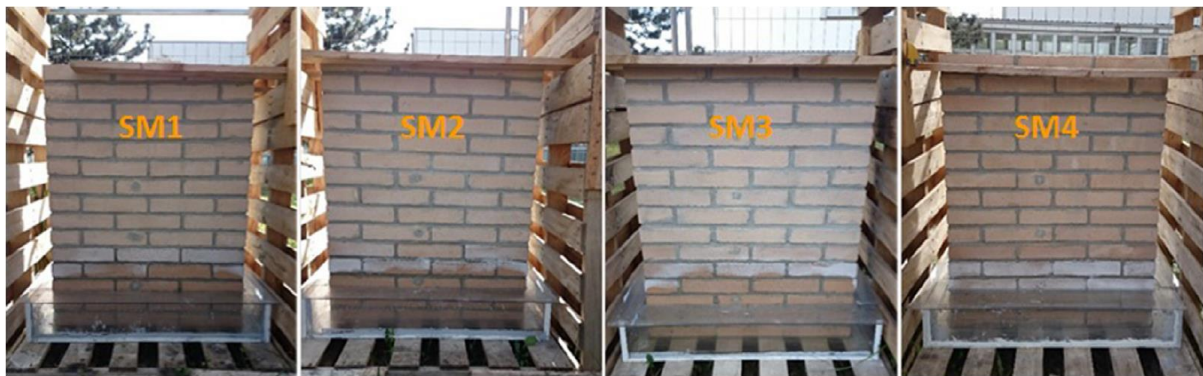
Figure 72: an overview of the 4 scale models, right before the treatments were applied. The humid zone, together with the expected salt efflorescences above the humid zone, are clearly visible. It is necessary to indicate that at this stage, no equilibrium is obtained: the rising damp has not yet reached its full height (usually in the order of 1 meter). But as the injection zone is already damp, at this stage the treatments can be carried out. It should be emphasized that at that very moment, the most salt-loaden zone (indicated by the efflorescences) is at a height around 20 cm above the water level. This is an important factor to fully understand the humidity distribution graphs (see below).

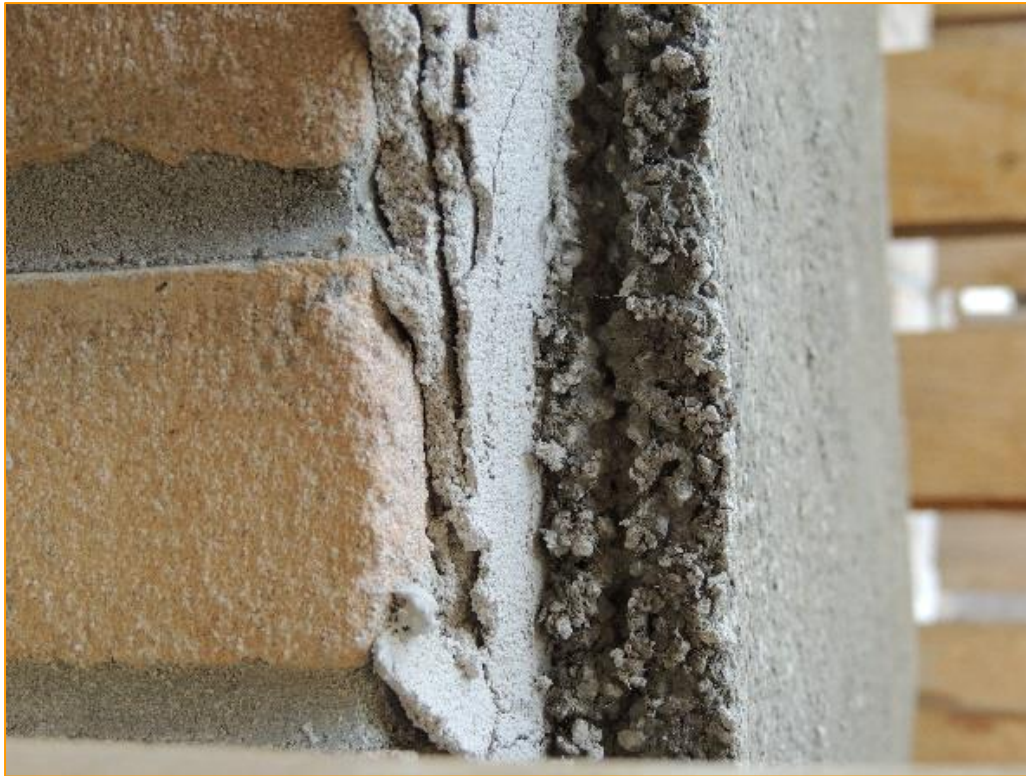
Figure 73: detail, showing the two layers of dehumidifying plaster on Scale model 4. One can clearly see the different thicknesses of the two layers, and their difference in nature.

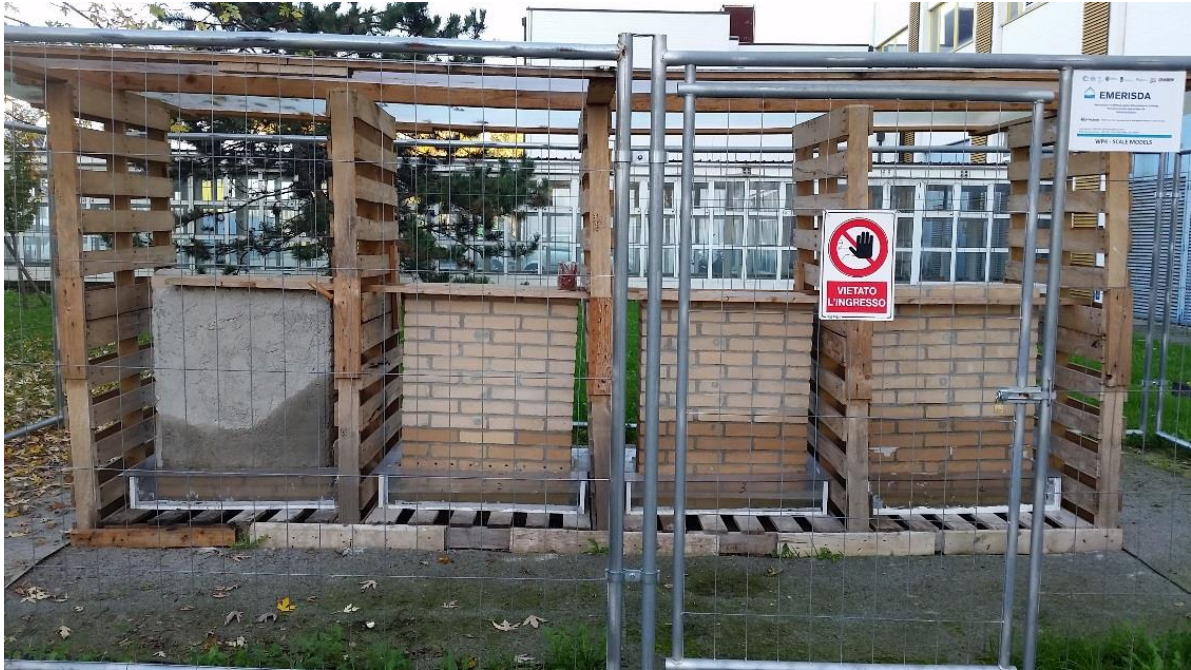
Figure 74: November 2015, 7 months after the treatment. One can clearly see lots of humidity in the scale models. At least part of this humidity is hygroscopic humidity, caused by hygroscopic water uptake by the salts in humid cold weather.

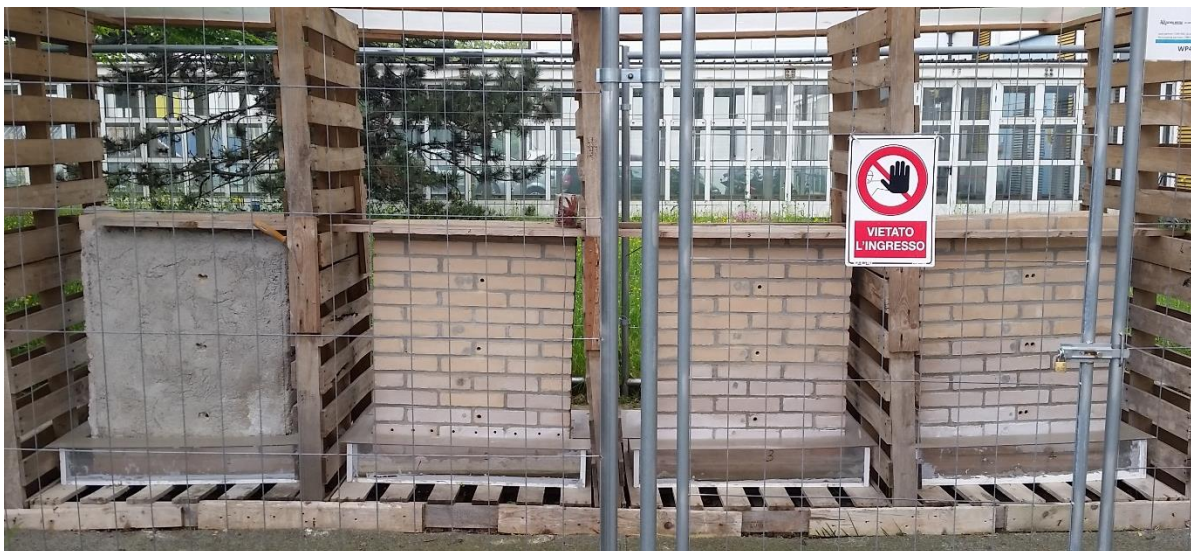
Figure 75: April 2016, 12 months after the treatment. The scale models seem to be dry (even the untreated scale model on the right). This effect arises from the fact that the weather is drier and warmer, thus causing the salts to dry out, as the relative humidity outside goes under the critical relative humidity of NaCl, around 75% RH.
