## [GEPATAR]

[GEotechnical and Patrimonial Archives Toolbox for ARchitectural conservation in Belgium]

**GEotechnical and Patrimonial Archives Toolbox for ARchitectural conservation in Belgium**

Contract - BR/132/A6/GEPATAR  
FINAL REPORT

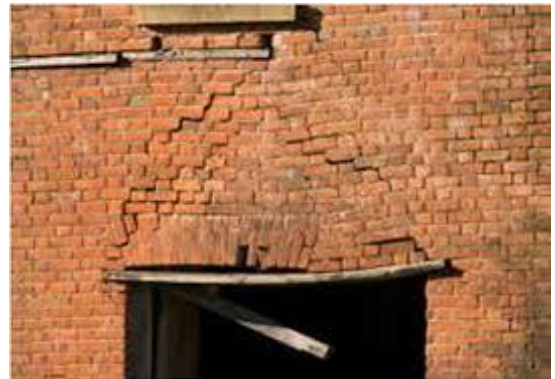
*Figure 1: Example of ground settlement damage*

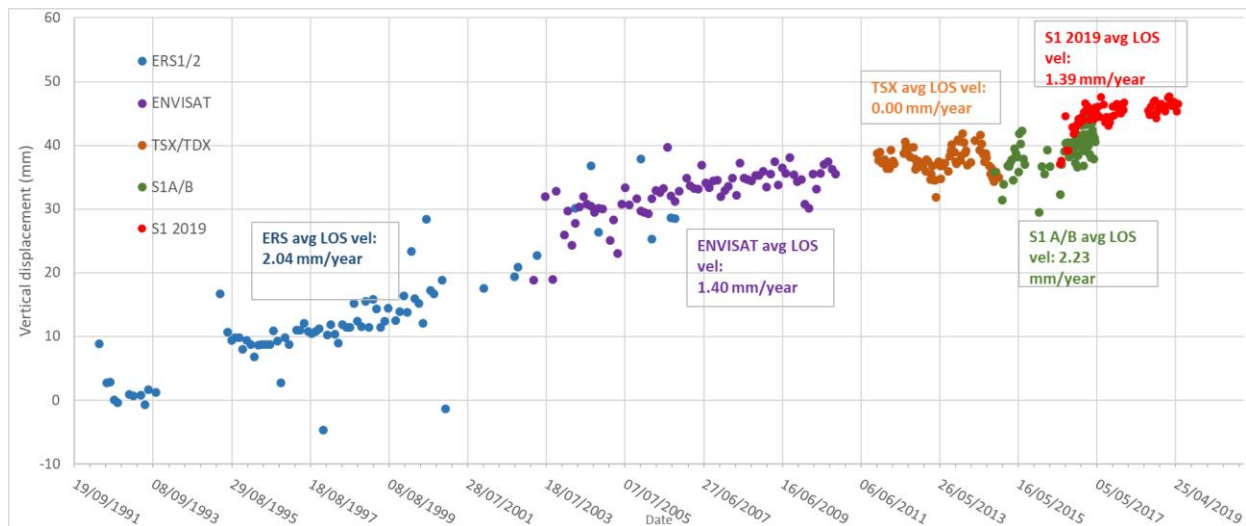
Figure 13 Time series of a PS showing the vertical displacement (in mm) located on the Tour & Taxis building.

The rebound of the piezometric levels of the deeper aquifers has been the driving force since the 1970s. The end of large-scale groundwater exploitations since the end of the industrialisation of the city is responsible for the groundwater recharge and piezometric level rise. This is attested by several modern (1988–2014) piezometric measurements in these aquifers and by historical piezometric levels in the deep Cretaceous aquifer (Figure 12). From 1880 to 1970, the city centre was probably subsiding due to the drop of the pore water pressures in the Cenozoic and the Palaeozoic aquifers resulting in a compaction of the rocks. The observed uplift rate in the city centre (Tour & Taxis building) is at its maximum during the ERS and ENVISAT periods and tends to reduce during TerraSAR-X and SENTINEL 1 period of time (Figure 13).
