Final report

CULTURAL HERITAGE IN CRISIS | CHRISIS

RT/22/CHRISIS

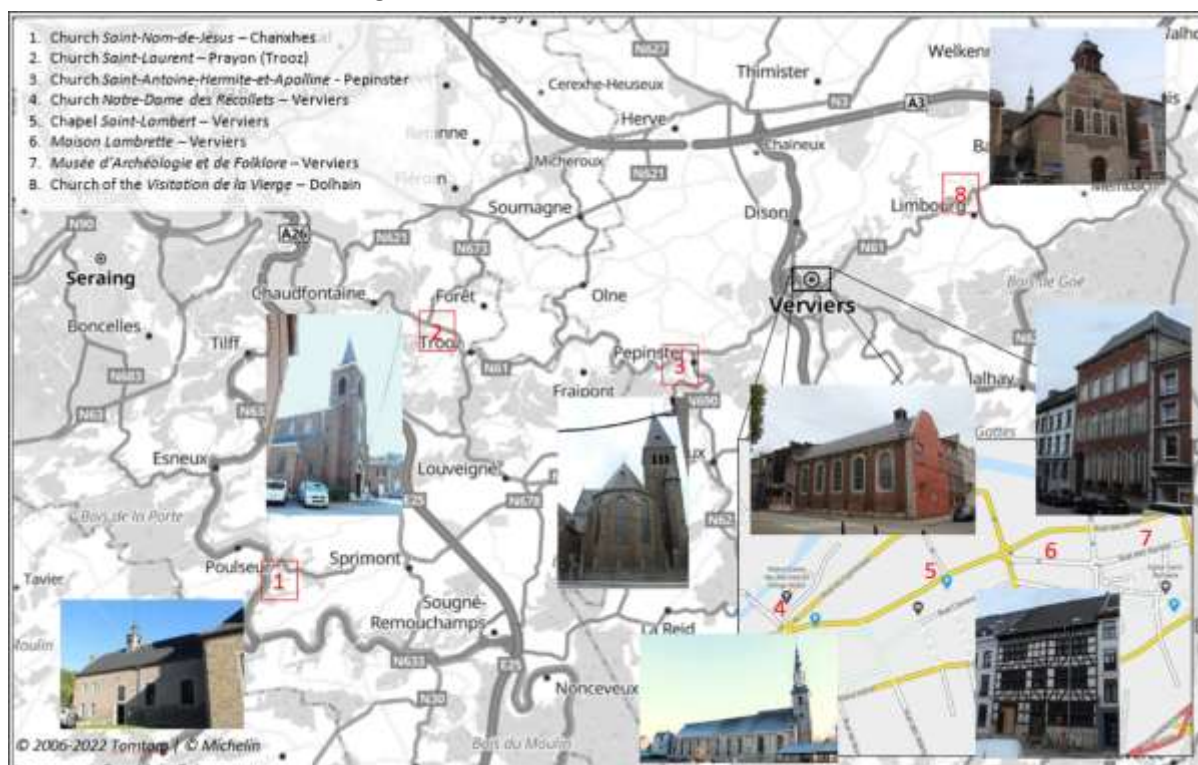
FIG. 5. Selected building used in this study © KIK-IRPA

Seven heritage buildings affected by the 2021 floods in the province de Liège in the Wallonia have been studied. They are composed of five churches, one dwelling and one museum both in high heritage value buildings (Fig. 5).

- The *Saint-Nom-de-Jésus* Church in Chanxhe
- The *Saint-Laurent* Church in Prayon (Trooz)
- The Saints-Antoine-Ermite-et-Apolline Church in Pepinster
- The Notre-Dame des Récollets Church in Verviers
- The *Saint-Lambert* Chapel in Verviers
- The *Maison Lambrette* in Verviers
- The Musée d'Archéologie et de folklore in Verviers

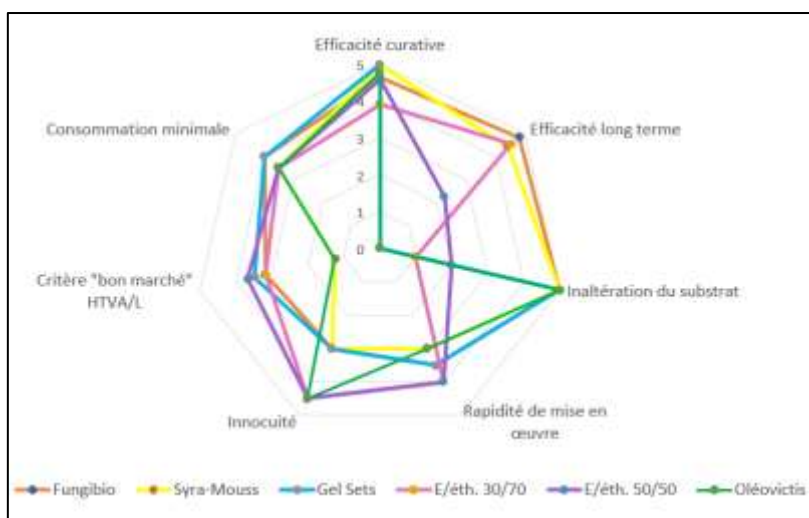
FIG. 8. Spider net to assess the biocide product in the church of Trooz after floods © KIK-IRPA

The assessment has been done by multicriteria methodology using 7 criteria (fig. 8):

- Biocide efficiency
- Long term efficiency
- Impact on substrate
- Duration of the application
- Innocuity
- Cost
- Consumption

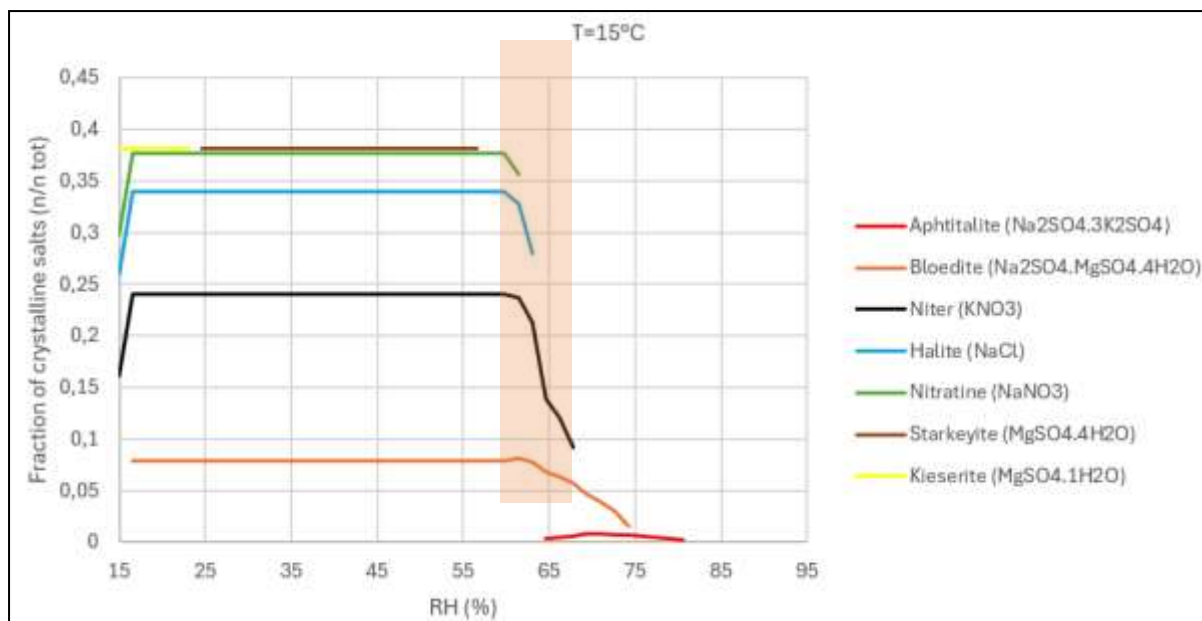
FIG. 12. Crystallization behaviour for a variable relative humidity. © KIK-IRPA

Crystallization behaviour for a variable relative humidity (15-95%) (0.2% resolution) (x-axis) at 20 °C at 15°C, of the mixture of ions detected in a joint mortar sample (after subtraction of an equimolar content of sodium, calcium, and sulphate ions) generated by the ECOS-Runsalt model. The relative amount of substance is given as a fraction of crystalline salt (n/n_{tot}) (y-axis). The sample was taken from the surface of the joint mortar at 50 cm above ground level. The beige areas represent the ranges of relative humidity causing solid/liquid phase changes of the salts present in the sample. Mole fractions: Cl^- : 0.0988, NO_3^- : 0.1989, SO_4^{2-} : 0.1625, Na^+ : 0.3063, K^+ : 0.2951, K^+ : 0.1611, and Mg^{2+} : 0.0833.

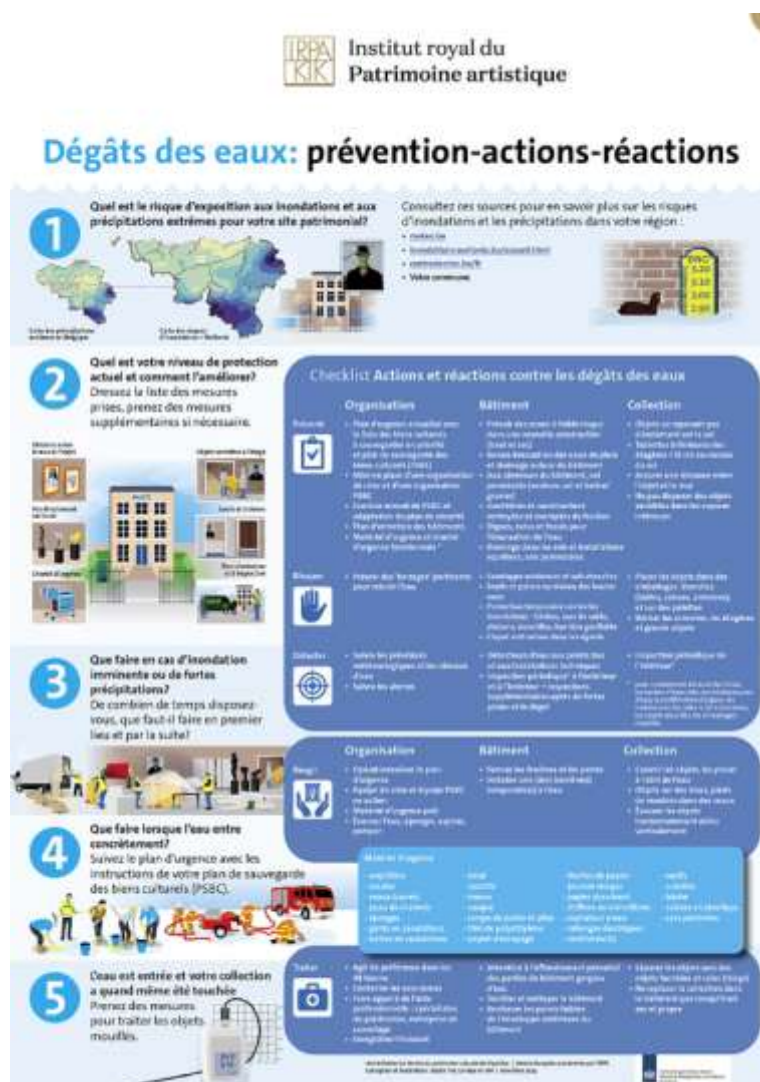
FIG. 16. Water Poster. © KIK-IRPA

One of the most practical tools created was the Water Damage Poster, which offers clear, step-by-step instructions for stabilizing heritage objects immediately after water-related incidents. Its visual format makes it suitable for display in storerooms, conservation workshops, and emergency planning offices. By condensing essential actions into an accessible resource, the poster supports rapid decision-making during crises. It is freely available online via the KIK-IRPA website, ensuring wide dissemination among heritage professionals.
