## **REDMONEST-BE2**

**Monitoring dynamic network for existing structures of concrete  
cultural patrimony**

**Contract - BR/132/A6/REDMONEST BE2**

## FINAL REPORT

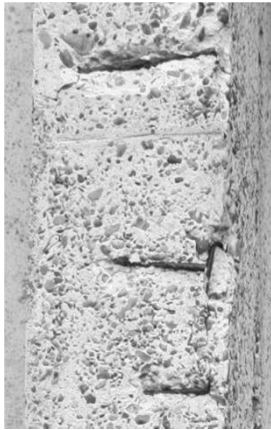
Figure 10: apparent horizontal reinforcement on a pillar (Saints Peter-and- Paul's west facade)

The visual inspection realized for the nine parish churches showed three main types of defects: concrete defects, structural defects and miscellaneous degradations. Defects related to concrete often appear in the form of spalling (Figs. 10 and 11) or cracks (Fig. 12). Steel corrosion seems to be the first cause of degradation (Fig. 10): in most cases indeed, rust marks are visible or reinforcement is rusted.

Steel corrosion may generally come from carbonation or chloride attack (Table 1). As the nine churches were built in urban environment, CO<sub>2</sub> induced carbonation process, which contributes to steel reinforcement corrosion [Emmons, 1993].

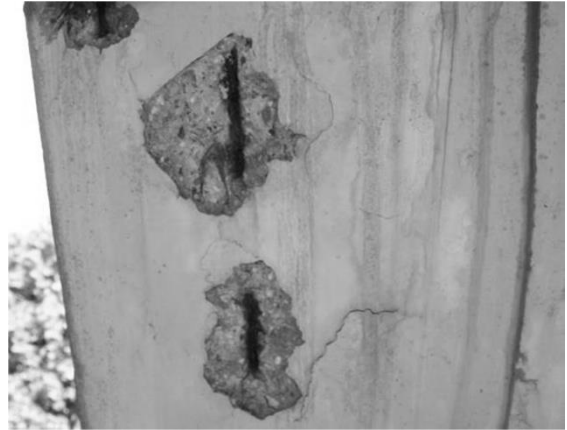
Figure 11: apparent reinforcement and rust marks on the bottom side of the stairs leading to Sainte Virgin Mary

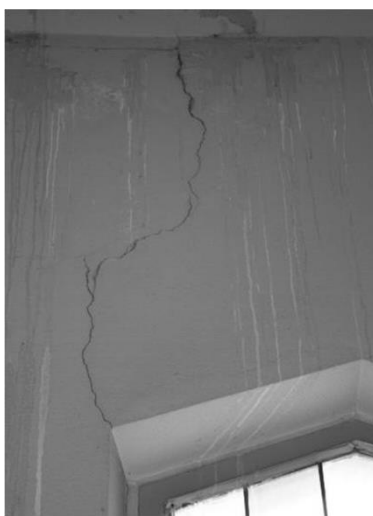
Figure 12: crack with various direction, appearing in an opening's angle (Saint Vincent's west facade)

Vertical, horizontal or inclined cracks are present in almost all the structures, indicating some structural damages. These may be caused by overloading, unbalanced loading, foundation movement... Cracks also appear in openings' angles, maybe due to hygrometric movement combined with restrained deformation. In any case, gauges should help to evaluate cracks evolution.

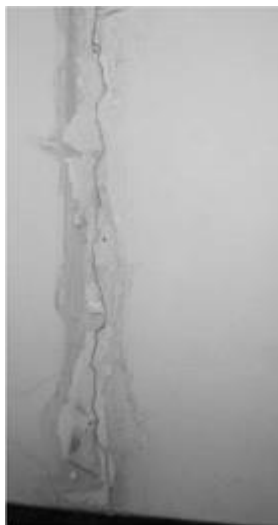
Figure 13: vertical crack in a pillar on the left of Saint Vincent's organ

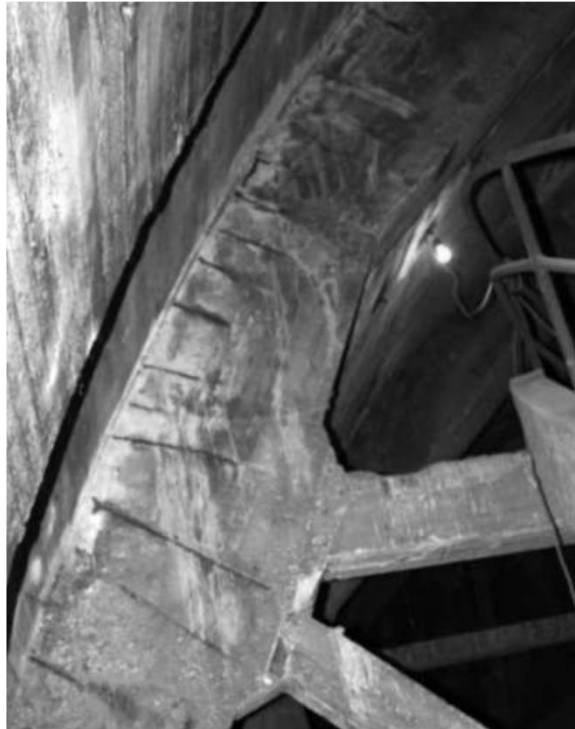
Figure 23: Reinforced concrete frame structures (between dome shells)

Archives shows that concrete was directly cast on the site and that traditional wooden plank sheeting (Figs 20 and 21) were used for casting; the absence of spacers resulted, in some cases, the positioning of the frame very close to the surface (Fig. 23).

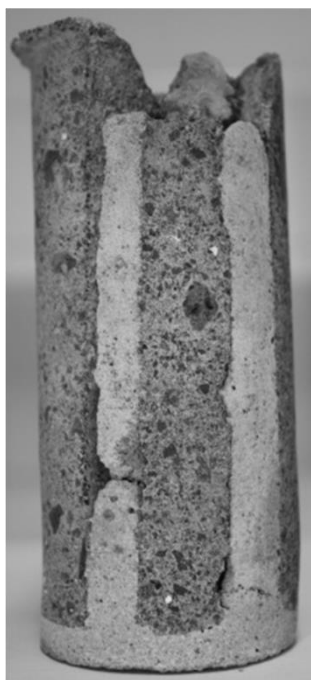
Figure 24: Sample of concrete (internal wall, Saint-Vincent church)

- a wall (apparently made of blocks) of concrete, 11 cm thick (Fig. 24);
- a vacuum of 13.5 cm thick;
- Pauchot reinforced artificial stone, about 16 cm thick (Figs 25 and 26).

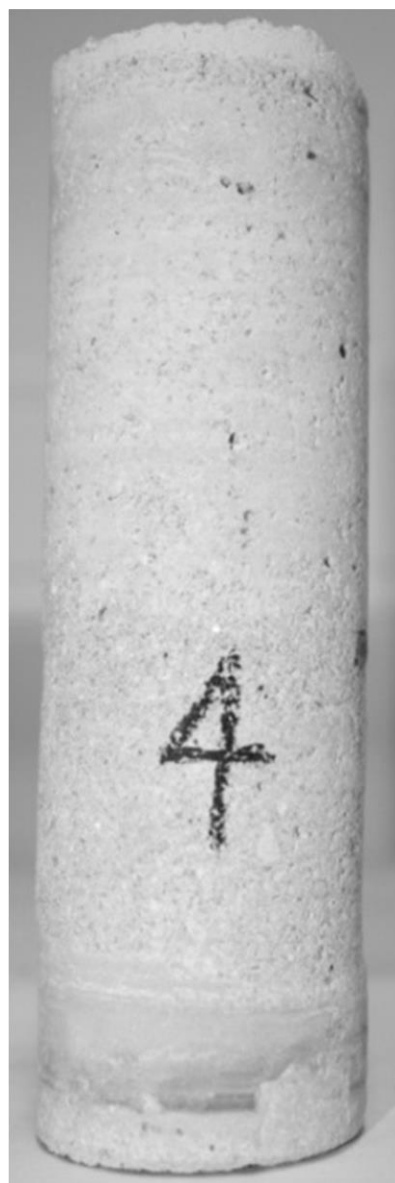
Figure 26: Sample of Pauchot reinforced artificial stone (external wall, Saint-Vincent church)

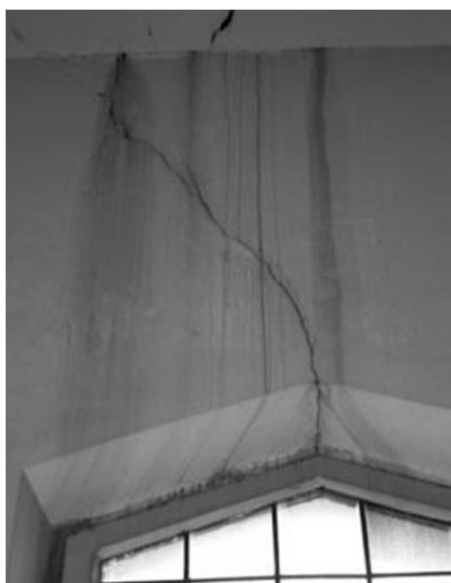
Figure 30: Crack in the central part of the beam above the by lighting the gallery (East front, Saint- Vincent Church)

- cracks without specific direction, in front of the monument (Fig. 30),
- oblique cracks on the beams between the pillars of the rotunda or the pillars of the apses or
- vertical cracks on some of the pillars of apses (Fig. 31).

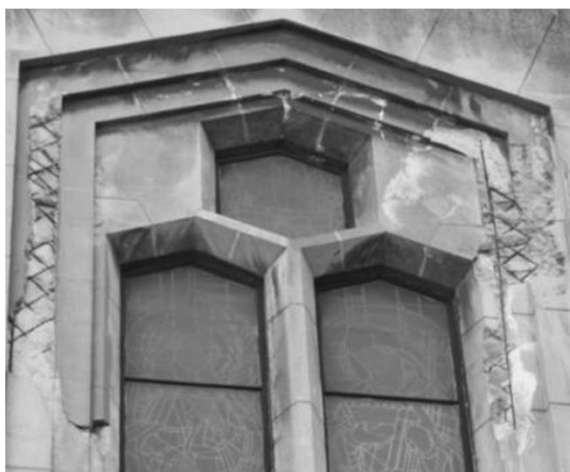
Figure 33: Spallings around the North West bay of the choir, Saint-Vincent Church

In addition, spalling was found as a main degradation all along the facade of the church (Figure 23), particularly around bays (Fig. 34). At this level, the cover of steel reinforcement is sometimes very thin (Figs 35 and 36). Other traces of spalling were visible in the stairwell and under the central dome (Fig. 23). Between the arches spanning the nave and the lantern, corroded steel bars are also flushing with concrete skin.

Carbonation depth and thin steel reinforcement cover are the main causes of spalling.

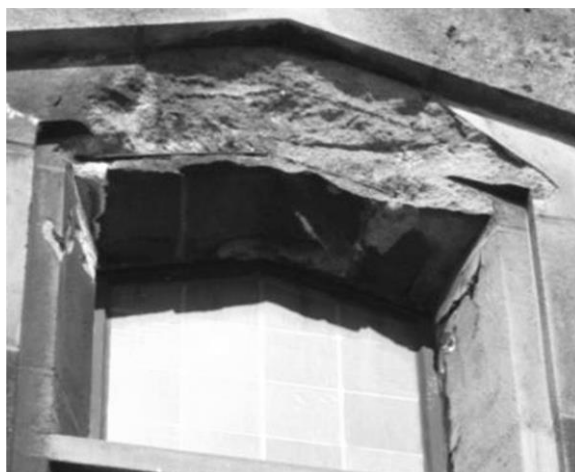
Figure 34: Spallings around a North bay, Saint-Vincent Church

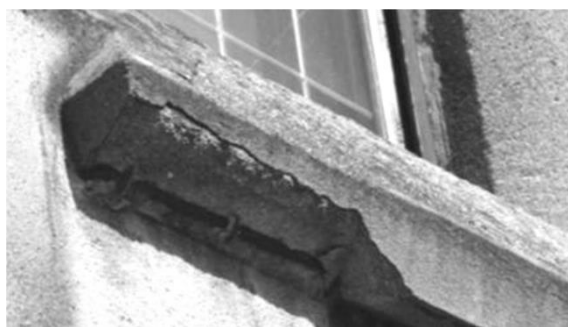
Figure 35: Spallings under window sill, Saint-Vincent Church

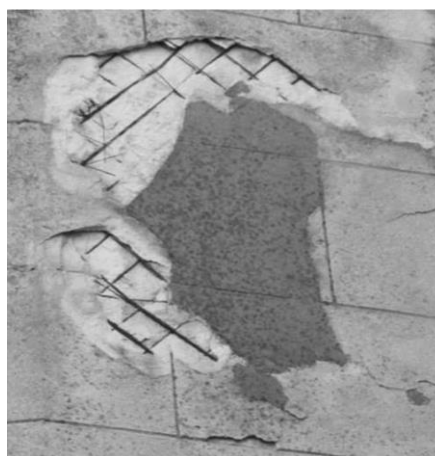
Figure 36: Typical spalling inside Pauchot reinforced artificial stone, North West apse, Saint-Vincent Church
